# Manhole Inspection Summary

Manhole # S45W\_\_026MH

Insp Date: **3/5/08 4:07 PM**

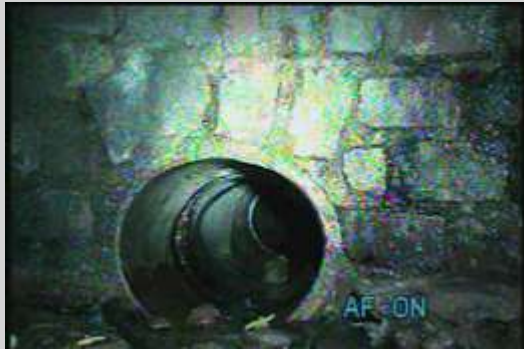
12 O'Clock Outflow

8 in. Circular Gravity Sewer  
Pipe Out @ 12 O'Clock

Pipe Material: **Clay** ☐ Pipe Lined

Invert Depth: **8.60** (ft.) Flow Characteristics: **None**

Deposits: ☒ None ☐ Mud ☐ Sludge ☐ Debris ☐ Grease

Infiltration: **None** Pipe Seal Cond: **Unknown**
